Obstruction Survey Memorandum and Analysis

As part of the Obstruction Removal Plan, Mead & Hunt (with Flightline Geomatics) performed a survey of trees at Truckee Tahoe Airport (TRK) June 9 through 11, 2020. The June 2020 survey helped further identify the location and elevation of trees that are penetrations to various airspace surfaces. This memorandum details the findings from this survey and is intended to guide the forester to help identify which trees are tagged or marked for removal. This memorandum also provides additional analysis of the June 2020 survey data points on Lahontan Hill.

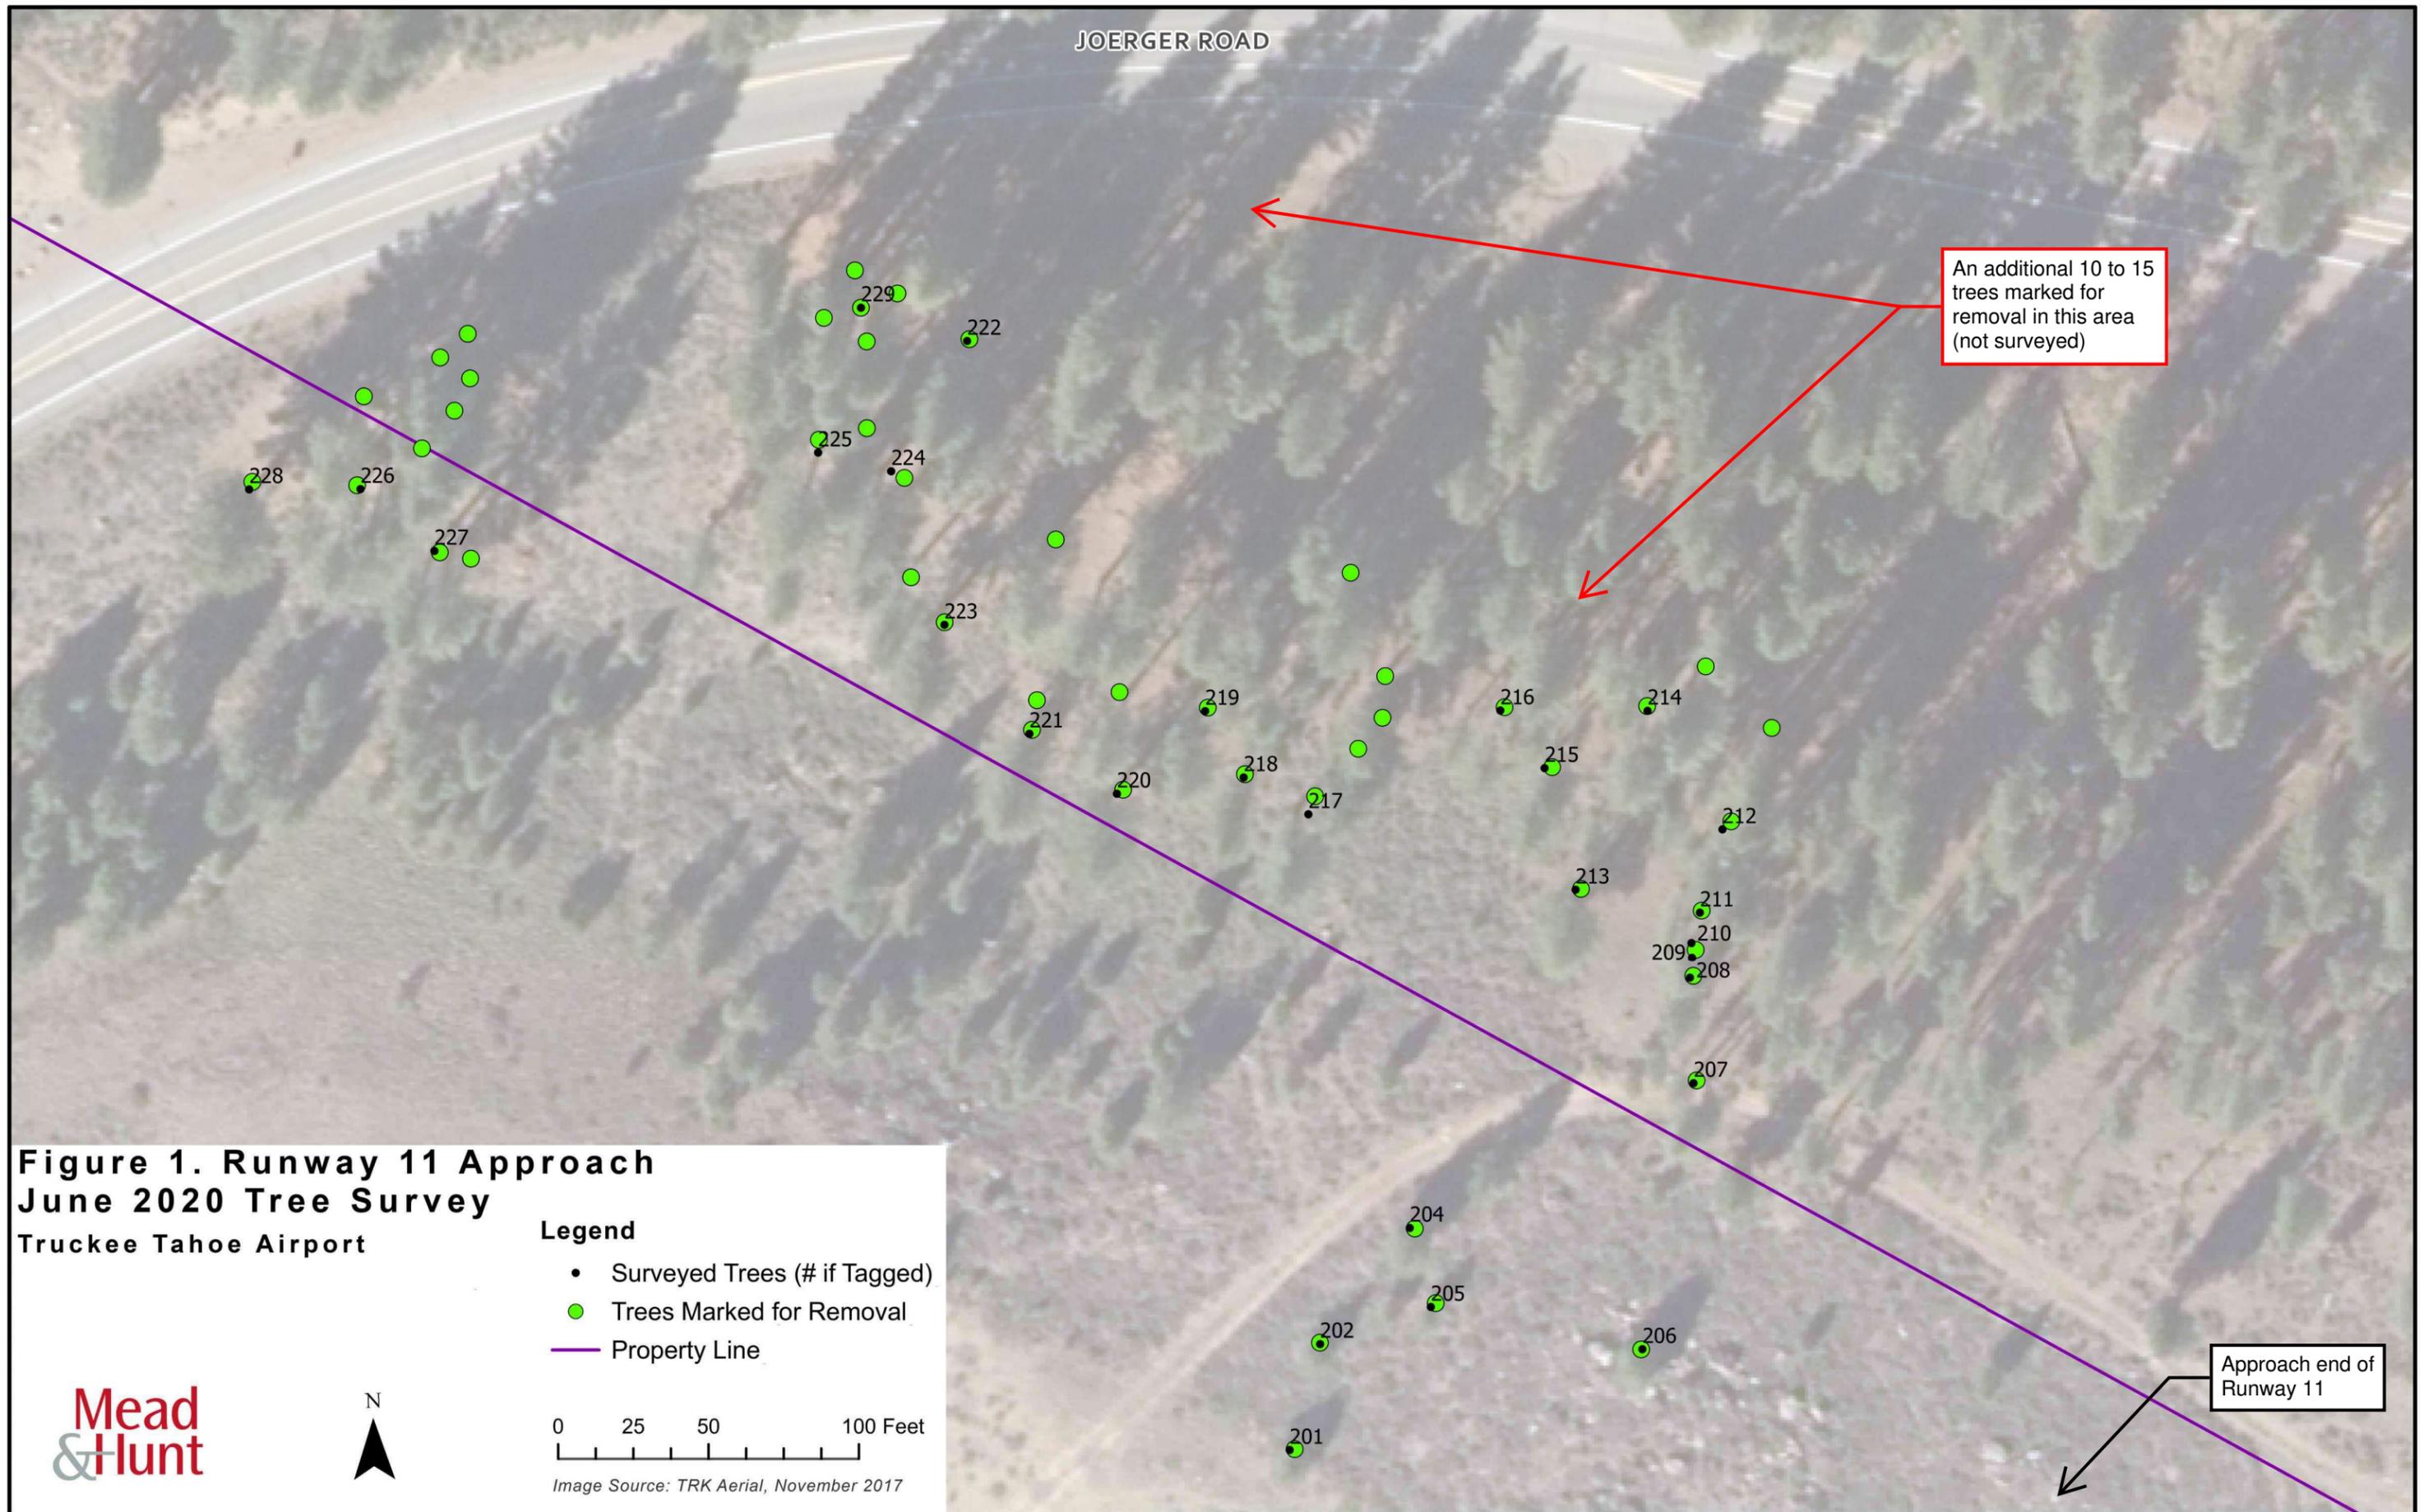
Trees that were tagged and marked for removal at the north side of the approach to Runway 11 are shown on **Figure 1**. Twenty-eight trees were tagged in this area that were found to be at or near the critical airspace surface. All trees identified as Priority 1 and 2 in the Obstruction Removal Plan were surveyed and tagged (12). The one exception is obstruction number 5071, which was tagged (#229) but not surveyed. For trees tagged at the approach end of Runway 11, tags were typically placed on the southeast side of the tree.

The green dots on **Figure 1** are trees from the AGIS survey that were marked in the field for removal. An additional 10 to 15 trees, not captured in the AGIS survey or the June 2020 survey, were marked for removal with paint in this area and are noted on the figure.

All trees were surveyed using a total station. The one exception is tree #205, which was obscured and was shot somewhere near the top and is identified in the point description as "SIDE." The elevation value for tree #205 is not the top of the tree.

The property line was delineated between the Highway 267 right-of-way to a point lateral (north) of the approach end of Runway 11. There were existing T-posts marking this line, all of which were found to be within 1 foot of the property line. Additional T-posts were set where needed. All posts were painted orange and flagged.

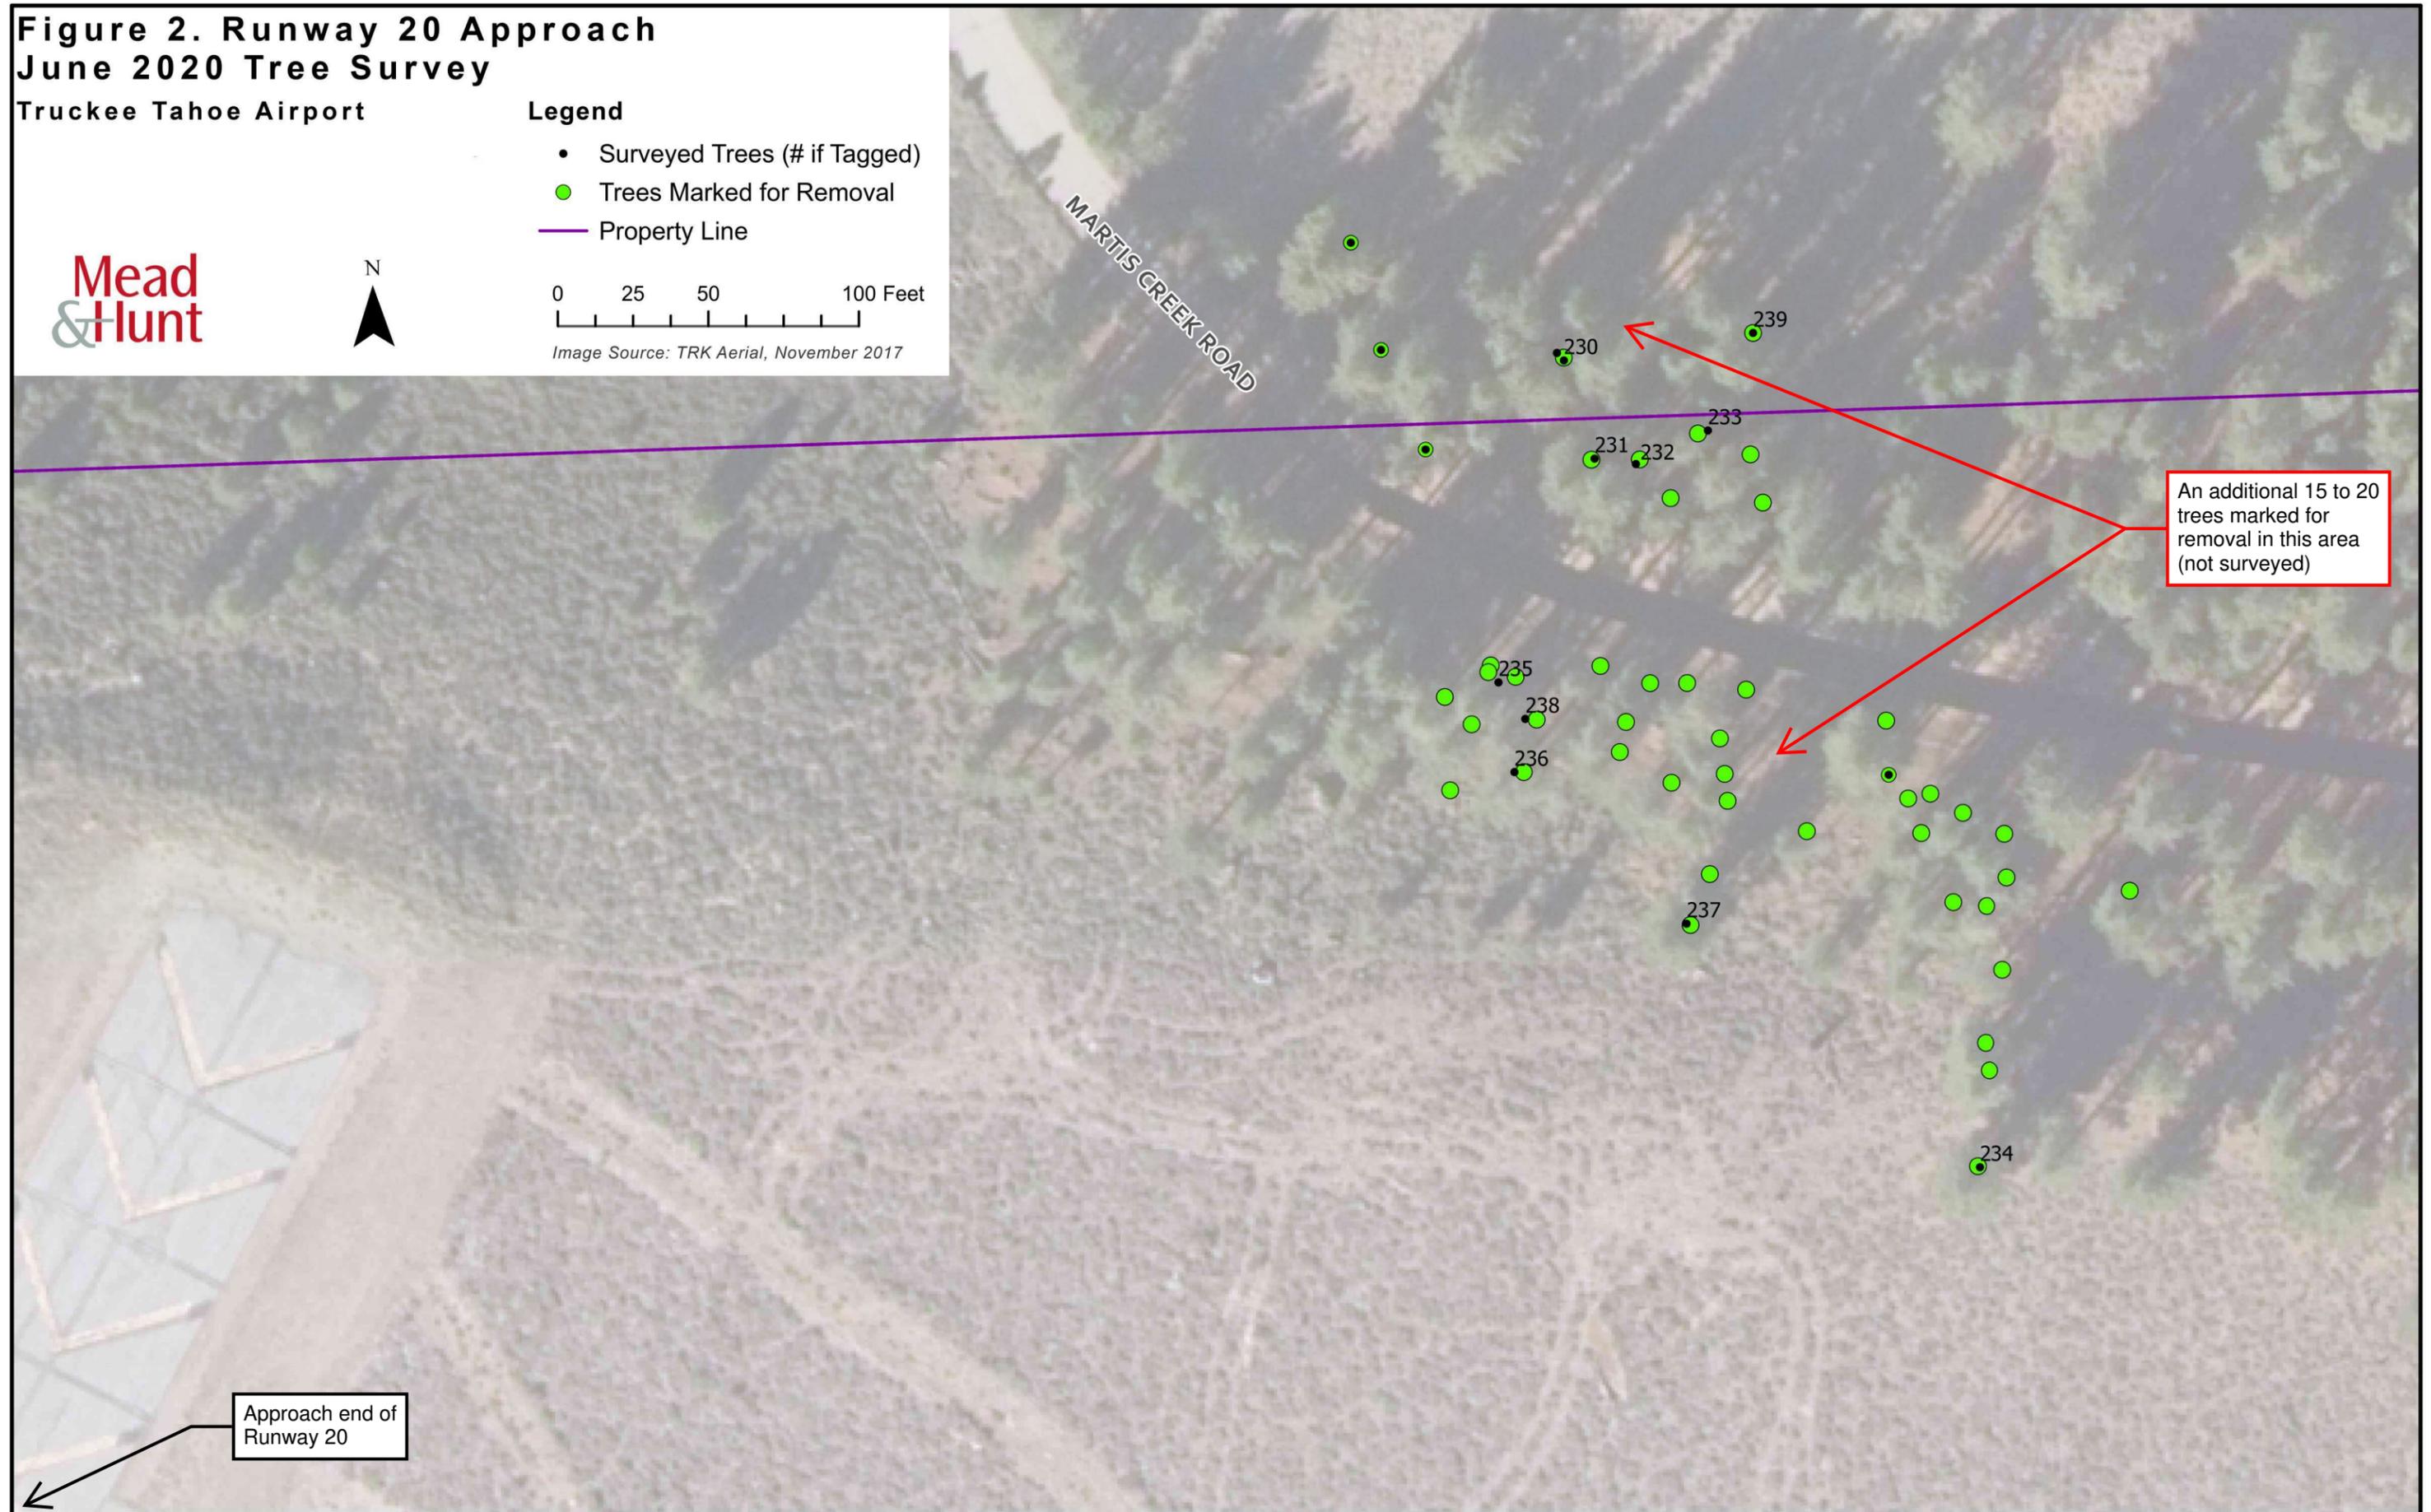
Figure 2. Runway 20 Approach June 2020 Tree Survey

Trees that were tagged and marked for removal at the east side of the approach to Runway 20 are shown on **Figure 2**. Ten trees were tagged in this area that were found to be at or near the critical airspace surface. All trees identified as Priority 1 and 2 in the Obstruction Removal Plan were surveyed and tagged (5). The one exception was tagged (#239) but not surveyed. At the Runway 20 approach end, tags were generally placed on the southwest side of the tree.

The green dots on Figure 2 are trees from the AGIS survey that were marked in the field for removal. An additional 15 to 20 trees, not captured in the AGIS survey or the June 2020 survey, were marked for removal with paint in this area and are noted on the figure.

All trees were surveyed using a total station. The one exception is tree #233, which was obscured and was shot somewhere near the top and is identified in the point description as "SIDE." The elevation value for tree #233 is not the top of the tree.

The property line was delineated from the northeast corner of Airport property west to the north 1/16th corner. It was found the property line was partially marked with T-posts, all of which were within 1 foot of the property line. Additional T-posts were set where needed. All T-posts were painted orange and flagged. One survey monument previously unknown to the surveyor was found along the line at the end of a SW-NE running barbed wire fence. The surveyor believes this corner to be out of position by approximately 6 feet. Additional work will be required to research this monument and conduct a boundary survey to resolve any conflicts.

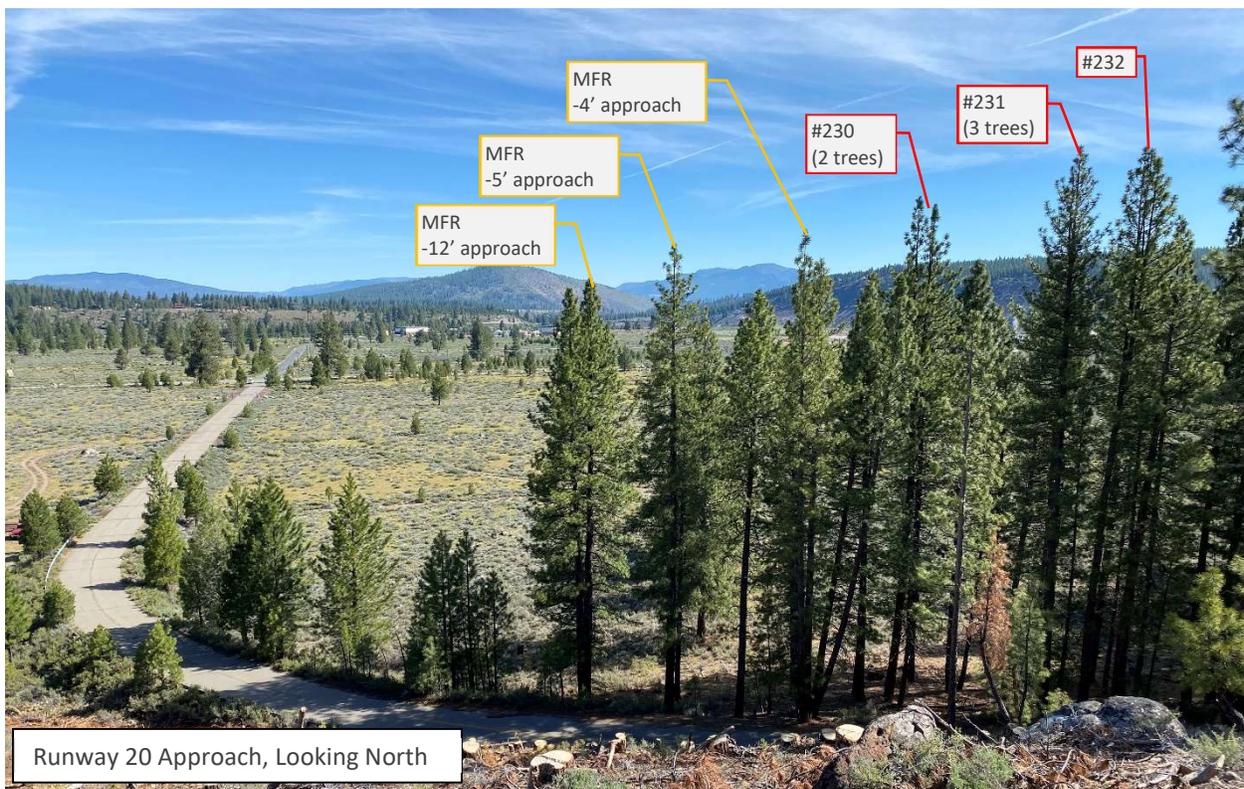
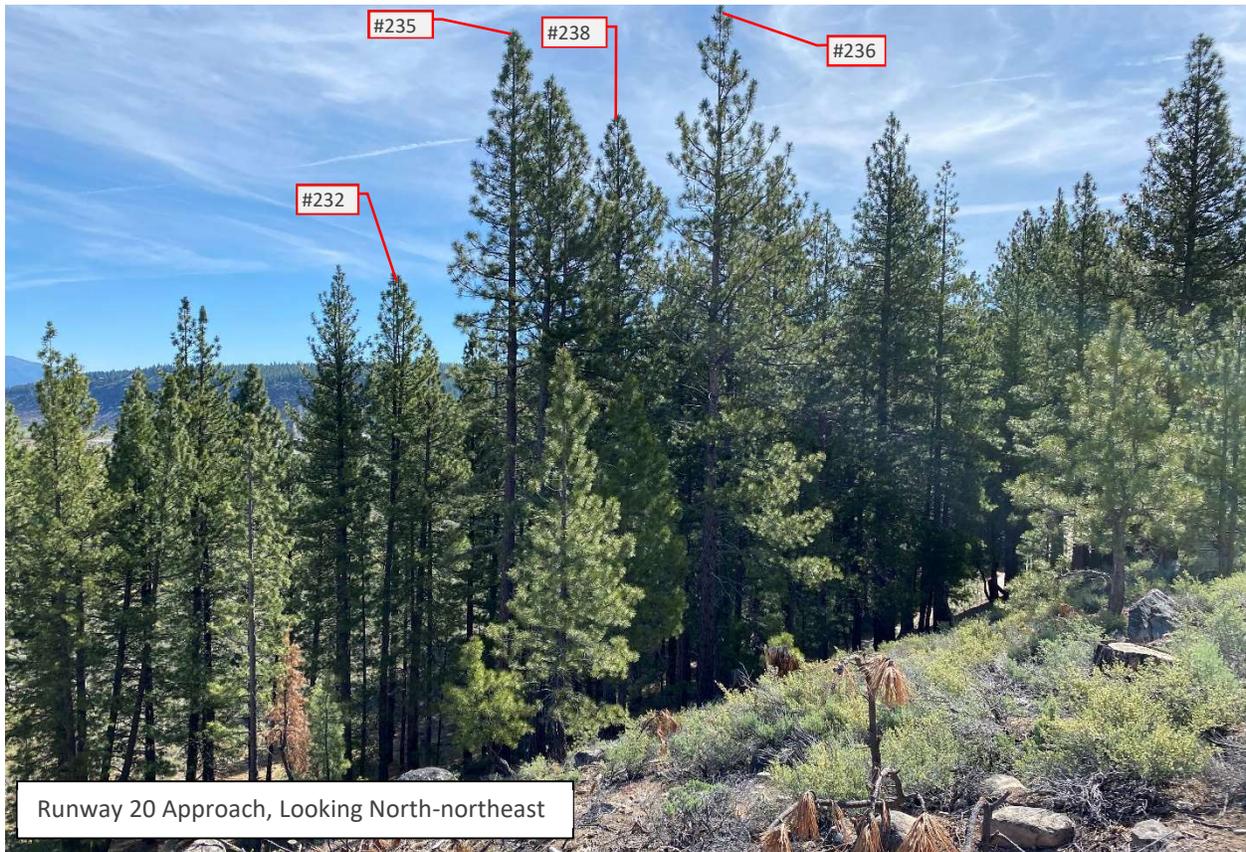
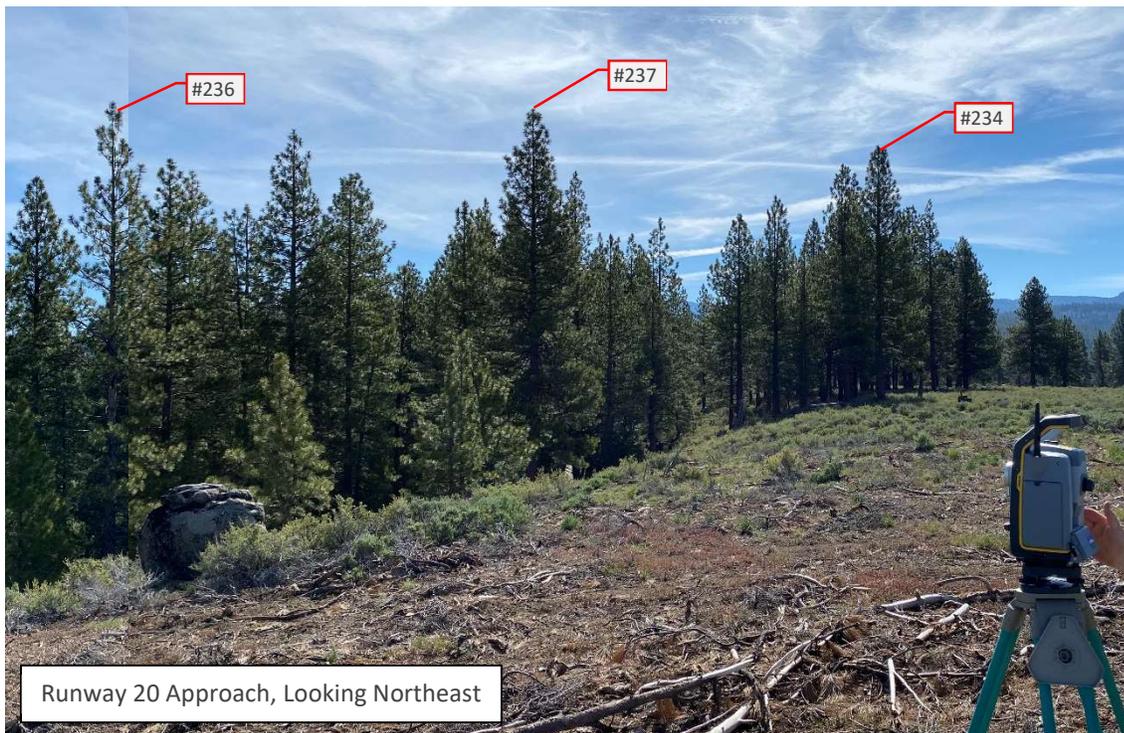
Photos below are of the approach end of Runway 20 to help the Airport and forester identify the tagged trees on the ground. The photos were taken June 10, 2020, with the photographer standing on the edge of the bluff looking northeast.

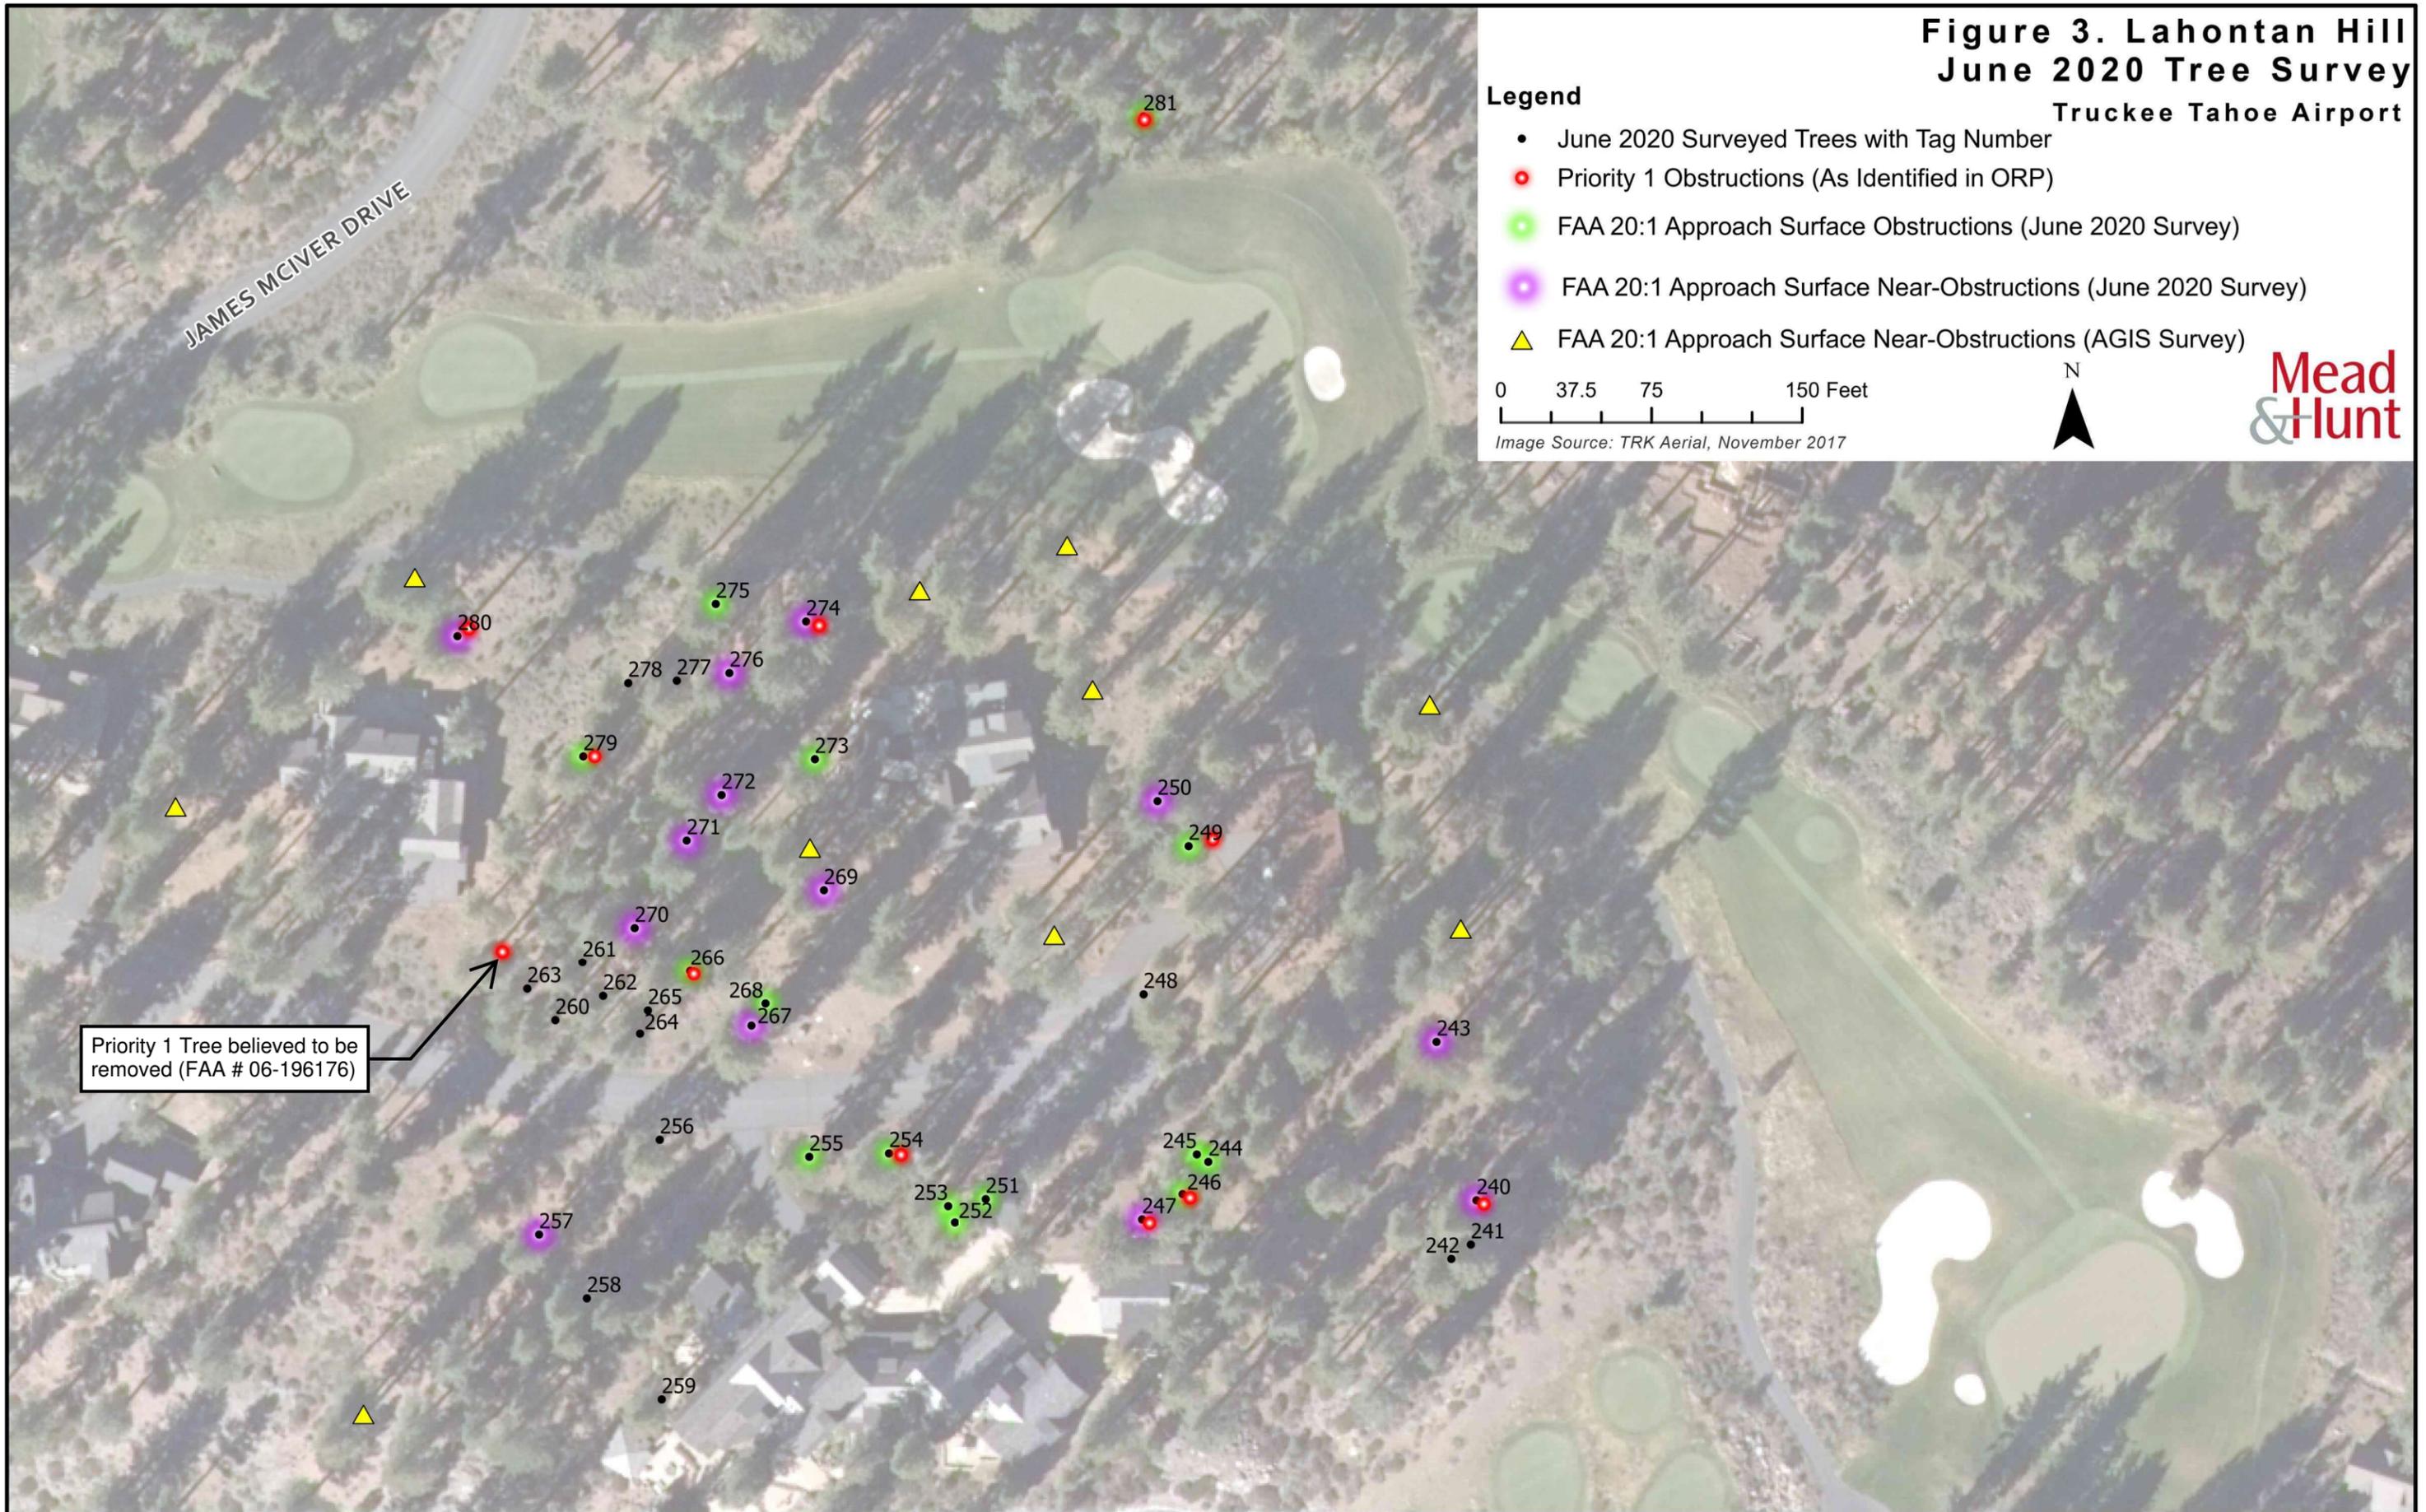
**Figure 3. Lahontan Hill
June 2020 Tree Survey
Truckee Tahoe Airport**

Figure 3 illustrates 40 trees that were tagged on Lahontan Hill near James McIver Drive with black dots and numbers. No trees were marked with paint for removal on Lahontan Hill since this is private property. All trees were surveyed at ground level using TRK GPS observations. Tree heights were then measured using a Nikon Forestry Pro II. Survey points were created in which the ground point was adjusted to the true horizontal position of the tree, and the elevation adjusted by adding the measured height to the observed ground elevation.

On **Figure 3**, different symbols represent trees of different characteristics:

- **Red dots:** Priority 1 trees, as identified in the Obstruction Removal Plan. All Priority 1 trees in the work area were surveyed and tagged. The one exception being FAA Obstruction Number 06-196176, which the survey teams believes was cut down.
- **Green Dots:** Trees surveyed in June 2020 that were found to be penetrations to the Runway 2 20:1 visual surface.
- **Purple Dots:** Trees surveyed in June 2020 that were found to be within 10 feet of the Runway 2 20:1 visual surface.
- **Yellow Triangles:** Trees from the 2017 AGIS survey that were found to be within 10 feet of the Runway 2 20:1 visual surface.

The Obstruction Removal Plan identified 11 trees as Priority 1 obstructions to the Runway 2, 20:1 visual surface. Of these, nine are in the FAA Instrument Flight Procedures Automation (IFPA) obstacle database (although only seven showed in a recent query). These are illustrated on **Figure 3** as red dots and documented in **Table 1** below. This shows the original analysis from the Obstruction Removal Plan with the location and elevation of each tree. This data was produced from the AGIS data set.

Priority 1 Tree believed to be removed (FAA # 06-196176)

The data in **Table 2** with **Figure 3** may be used by the Airport to determine if mitigation on Lahontan Hill is practical and economical.

- Table 2 provides the Airport an inventory of trees that are penetrations to or are near to the Runway 20 20:1 Visual Surface.
- While the vertical data has some minor discrepancies, the June 2020 survey data correlates well with the 2017 AGIS data.
- Analysis shows that FAA flagged some trees as obstacles that are clear of the 20:1 Visual Surface. This suggests the FAA may flag any trees as obstacles in the future that are near penetrations to the surface.
- Table 2 also shows that individual data points captured in the AGIS or June 2020 surveys are actually multiple trees. The survey team looked to group trees that had similar elevations, proximity, and diameter.

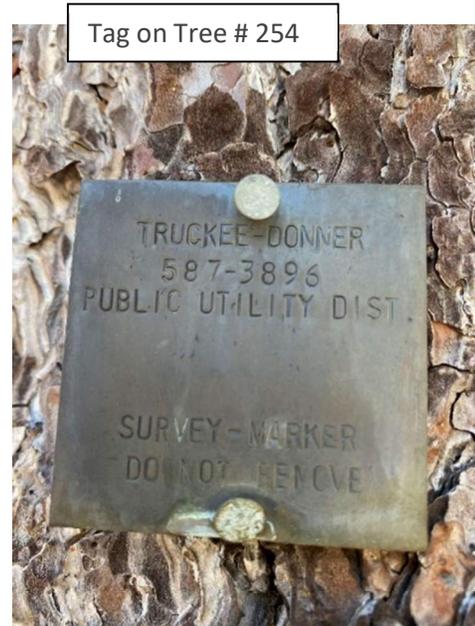
Photos taken on June 11, 2020, are included below to help the Airport identify trees on the ground, and trees that were grouped together.
