Obstruction Survey Memorandum and Analysis

As part of the Obstruction Removal Plan, Mead & Hunt (with Flightline Geomatics) performed a survey of trees at Truckee Tahoe Airport (TRK) June 9 through 11, 2020. The June 2020 survey helped further identify the location and elevation of trees that are penetrations to various airspace surfaces. This memorandum details the findings from this survey and is intended to guide the forester to help identify which trees are tagged or marked for removal. This memorandum also provides additional analysis of the June 2020 survey data points on Lahontan Hill.

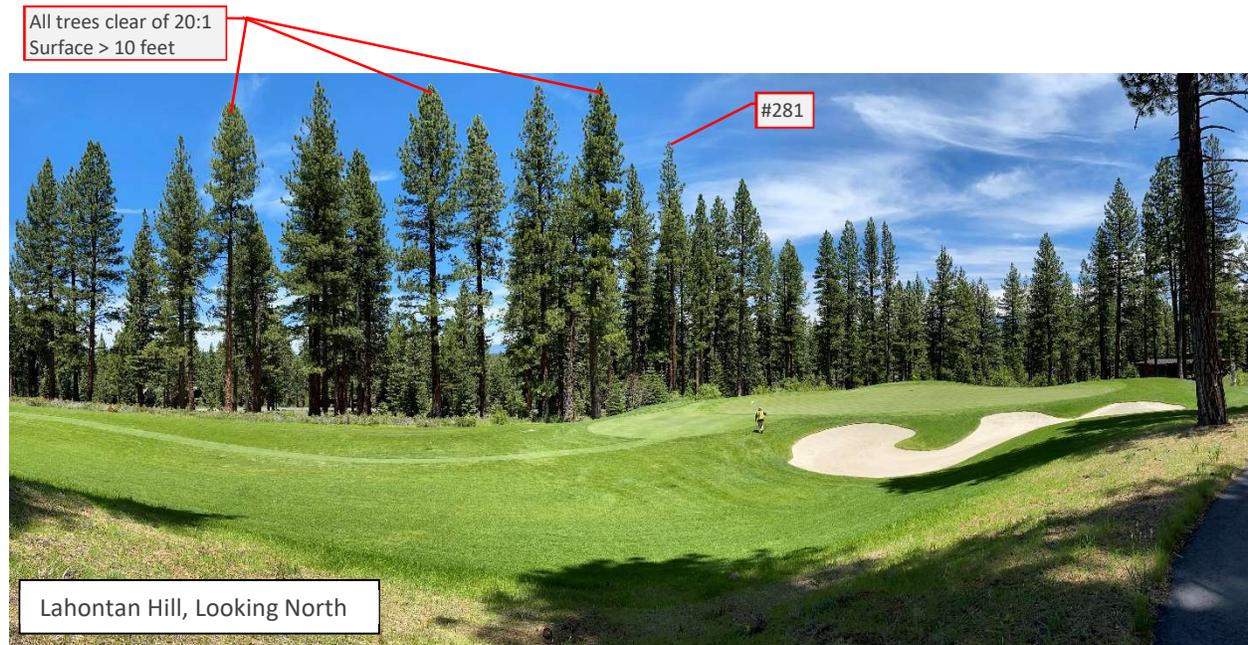
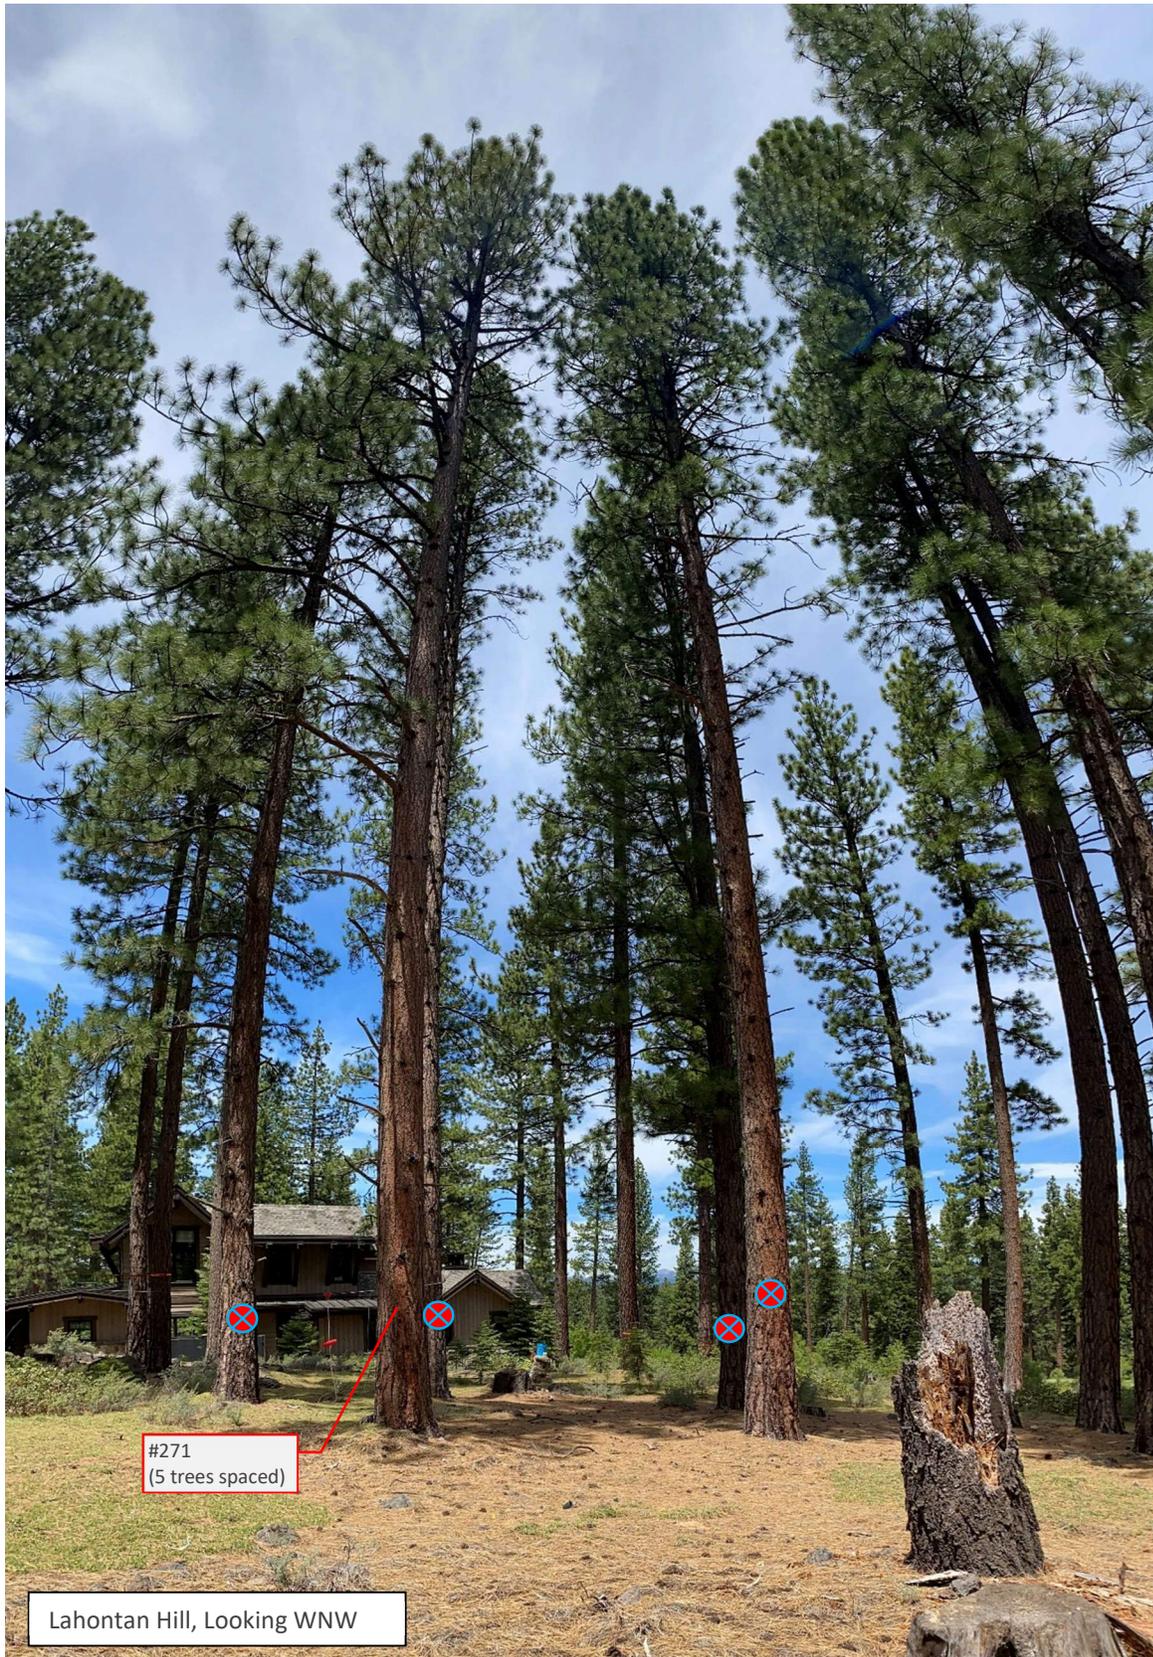
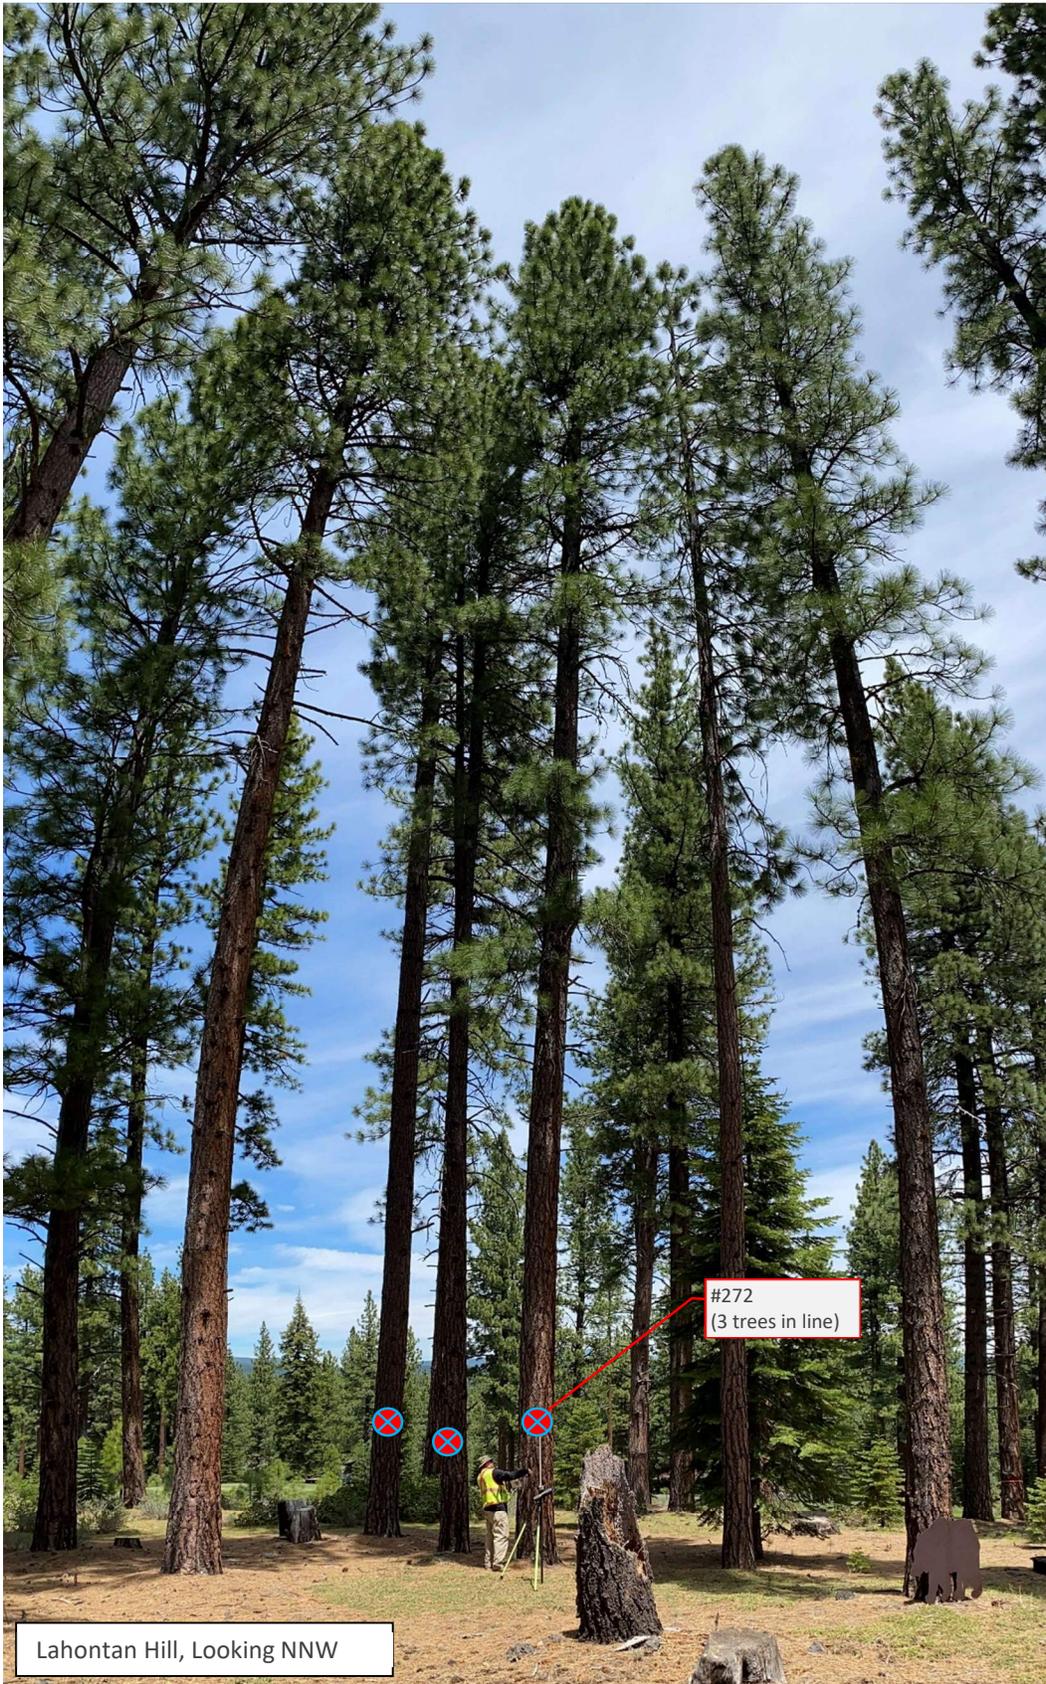
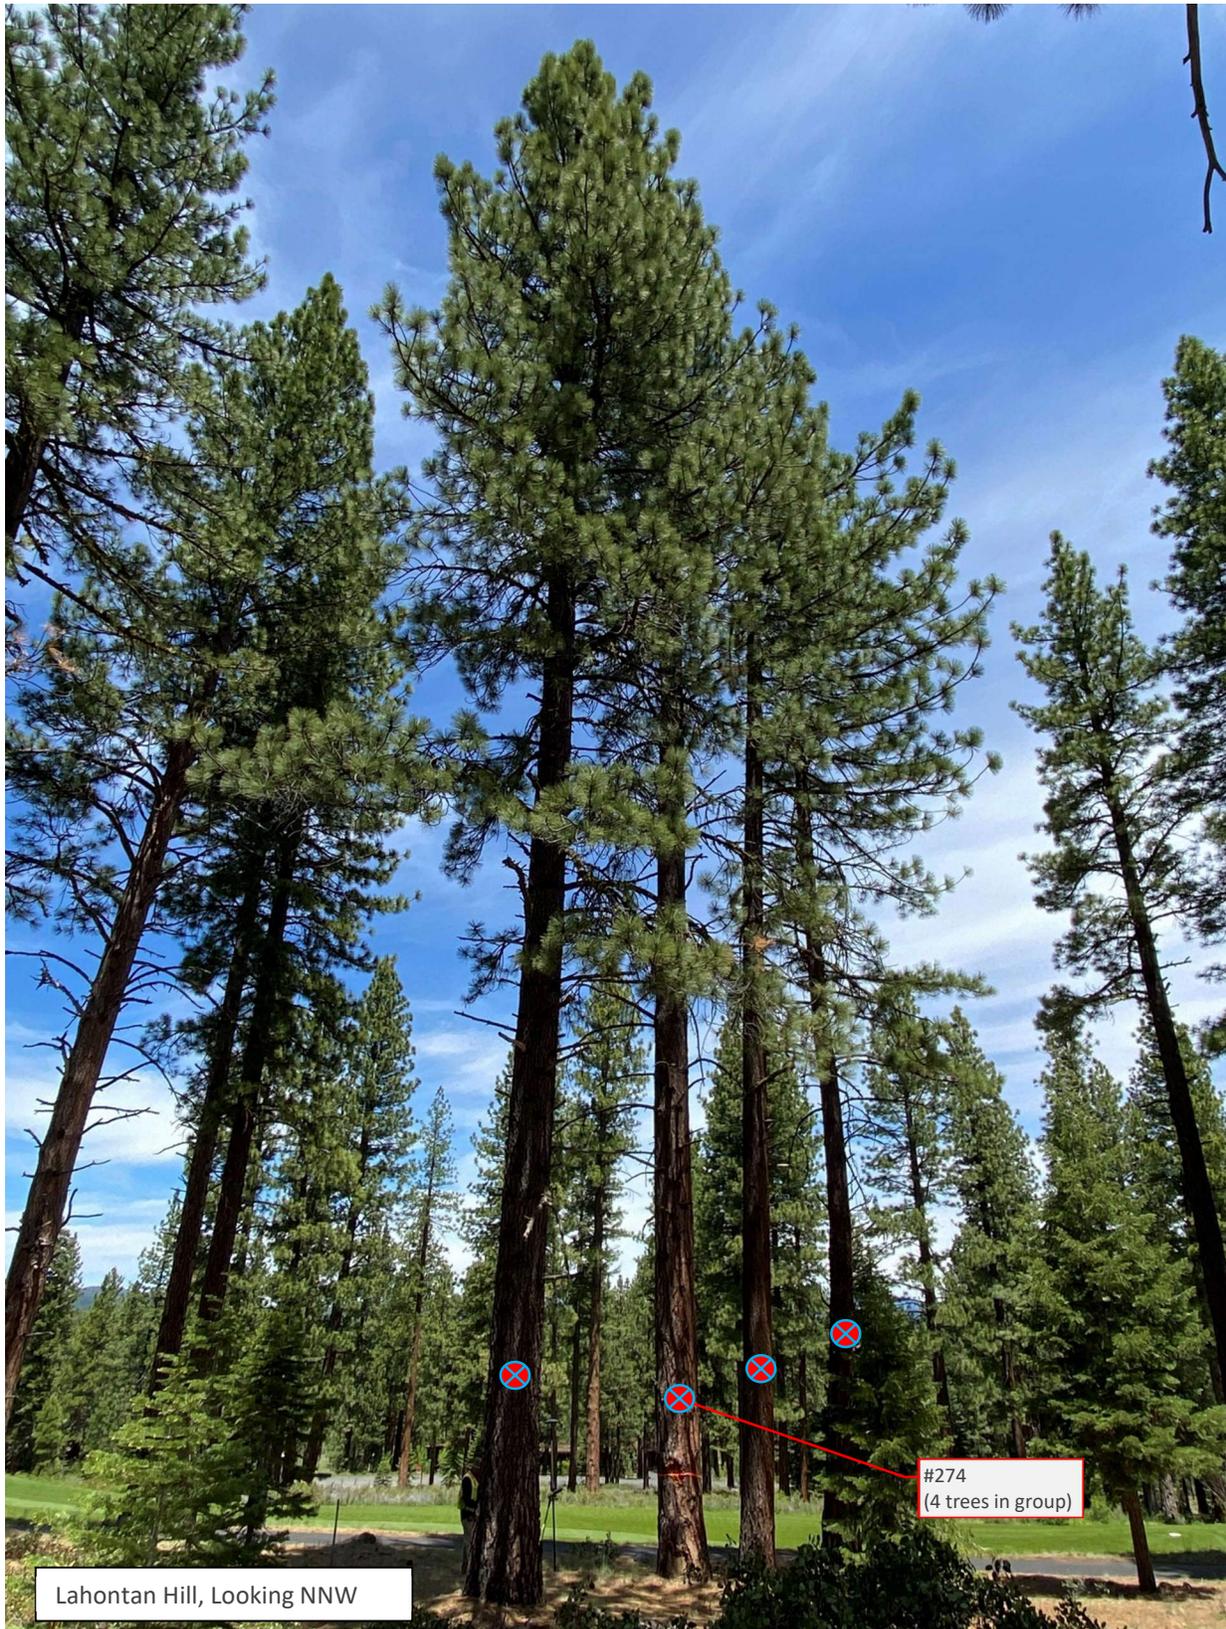
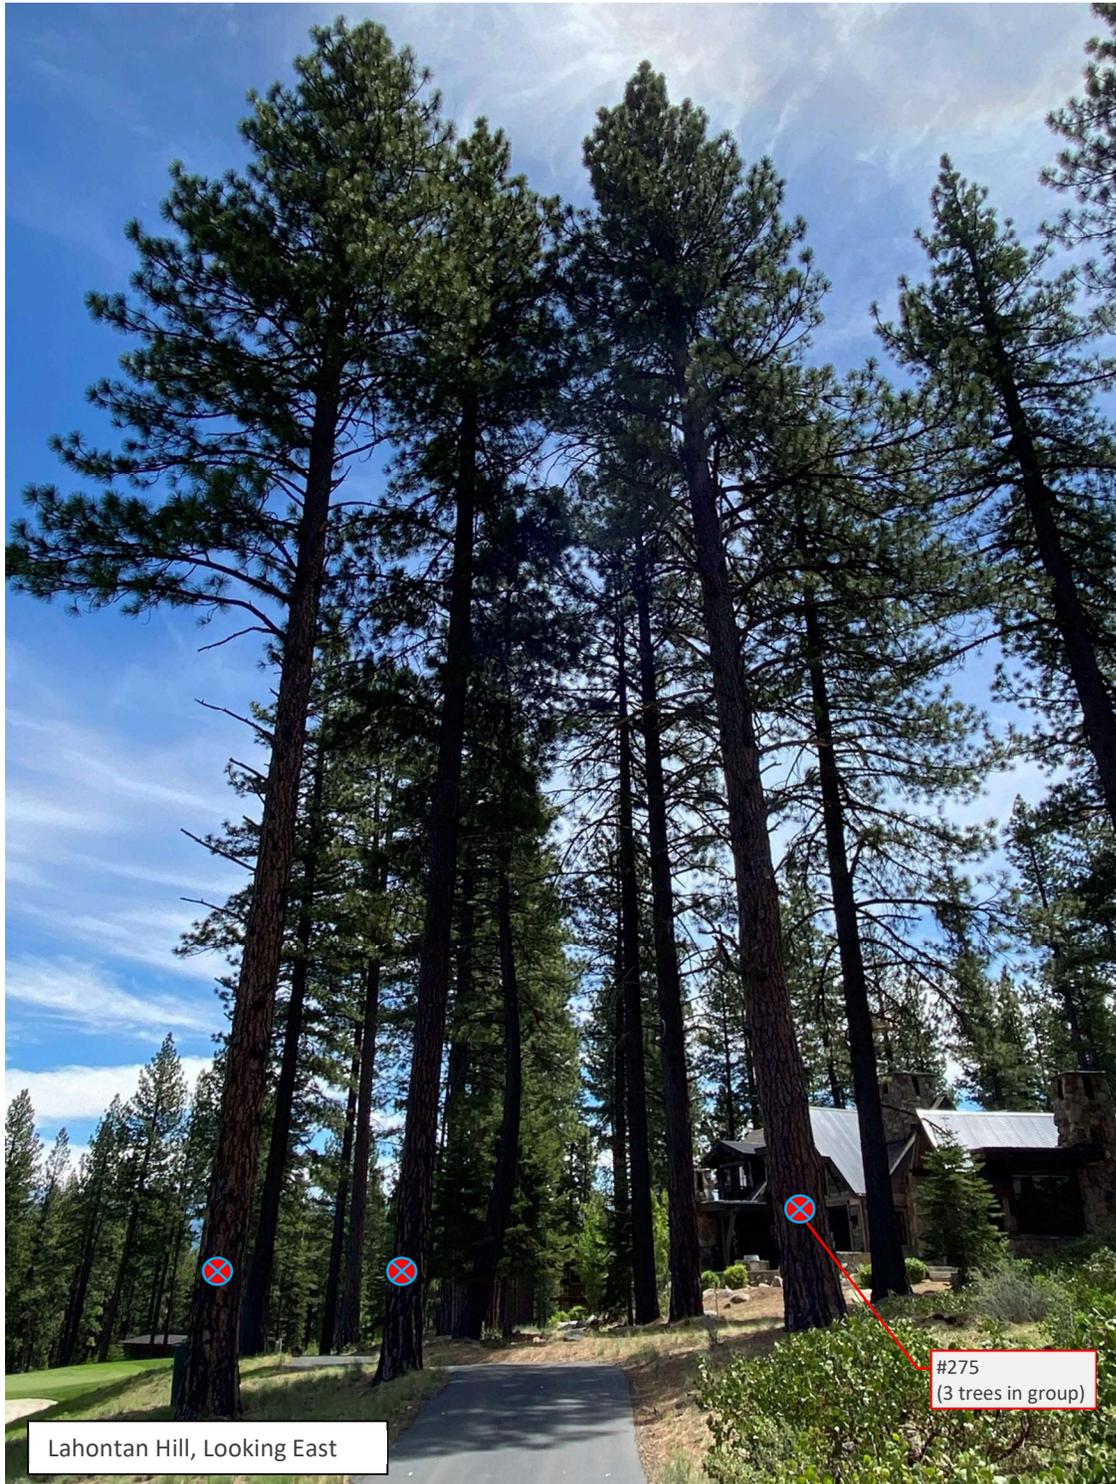
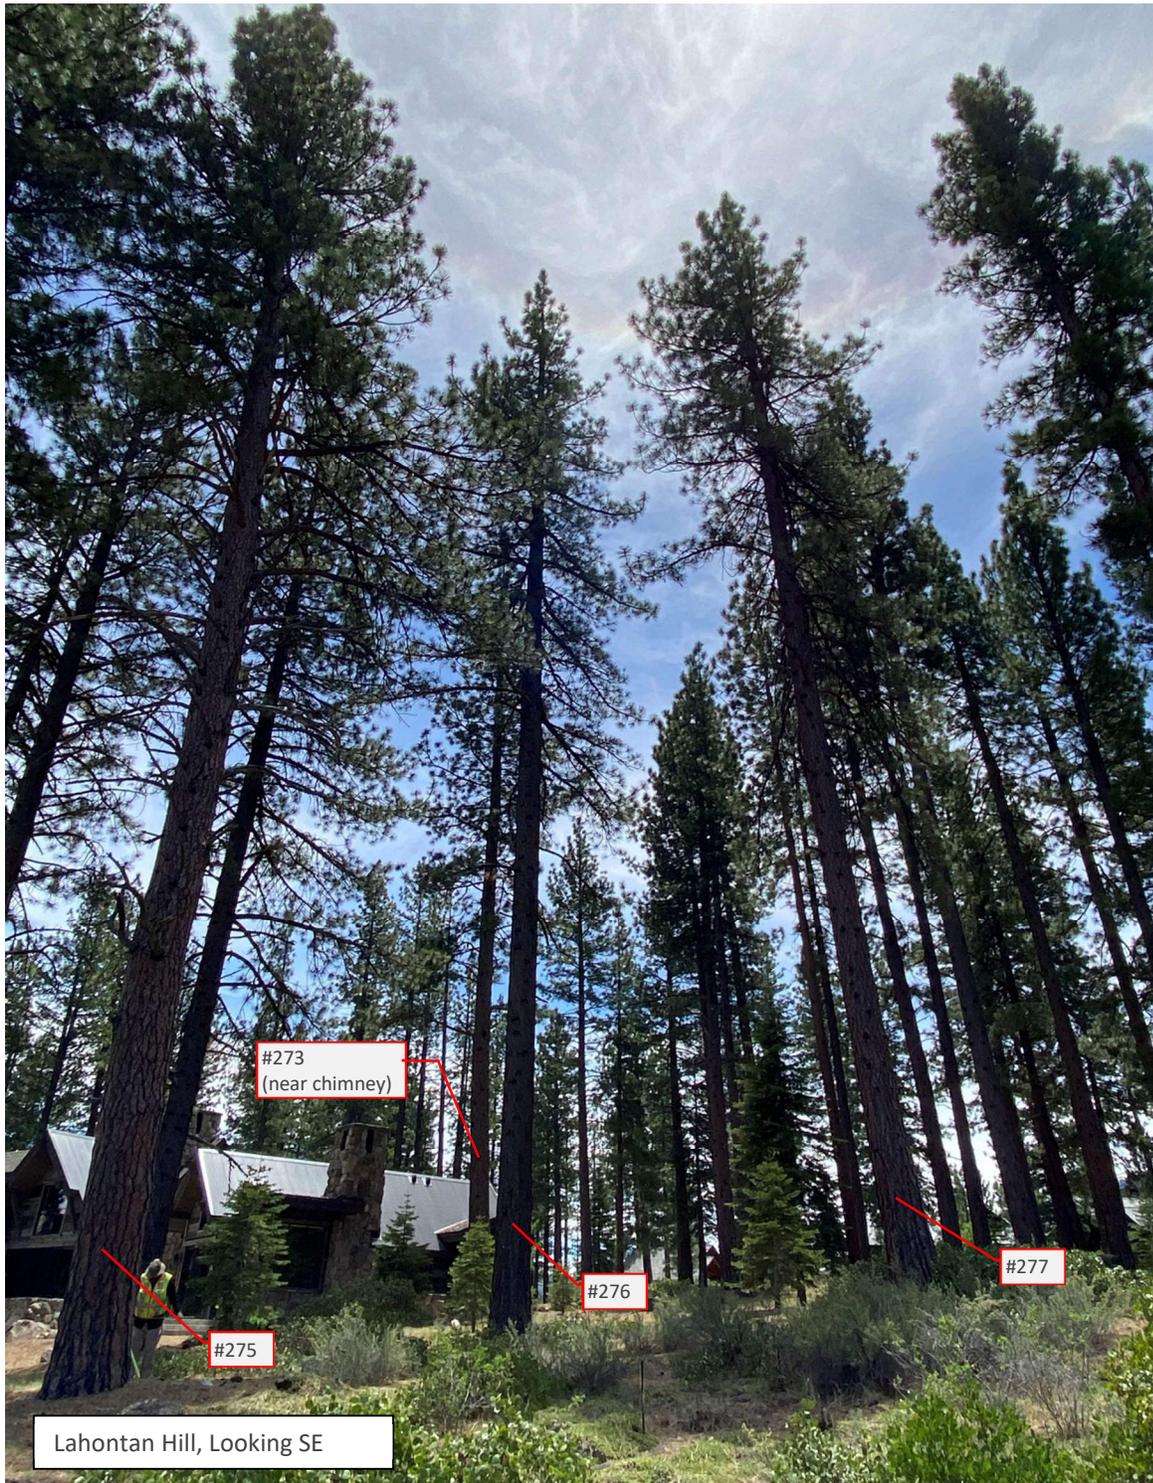
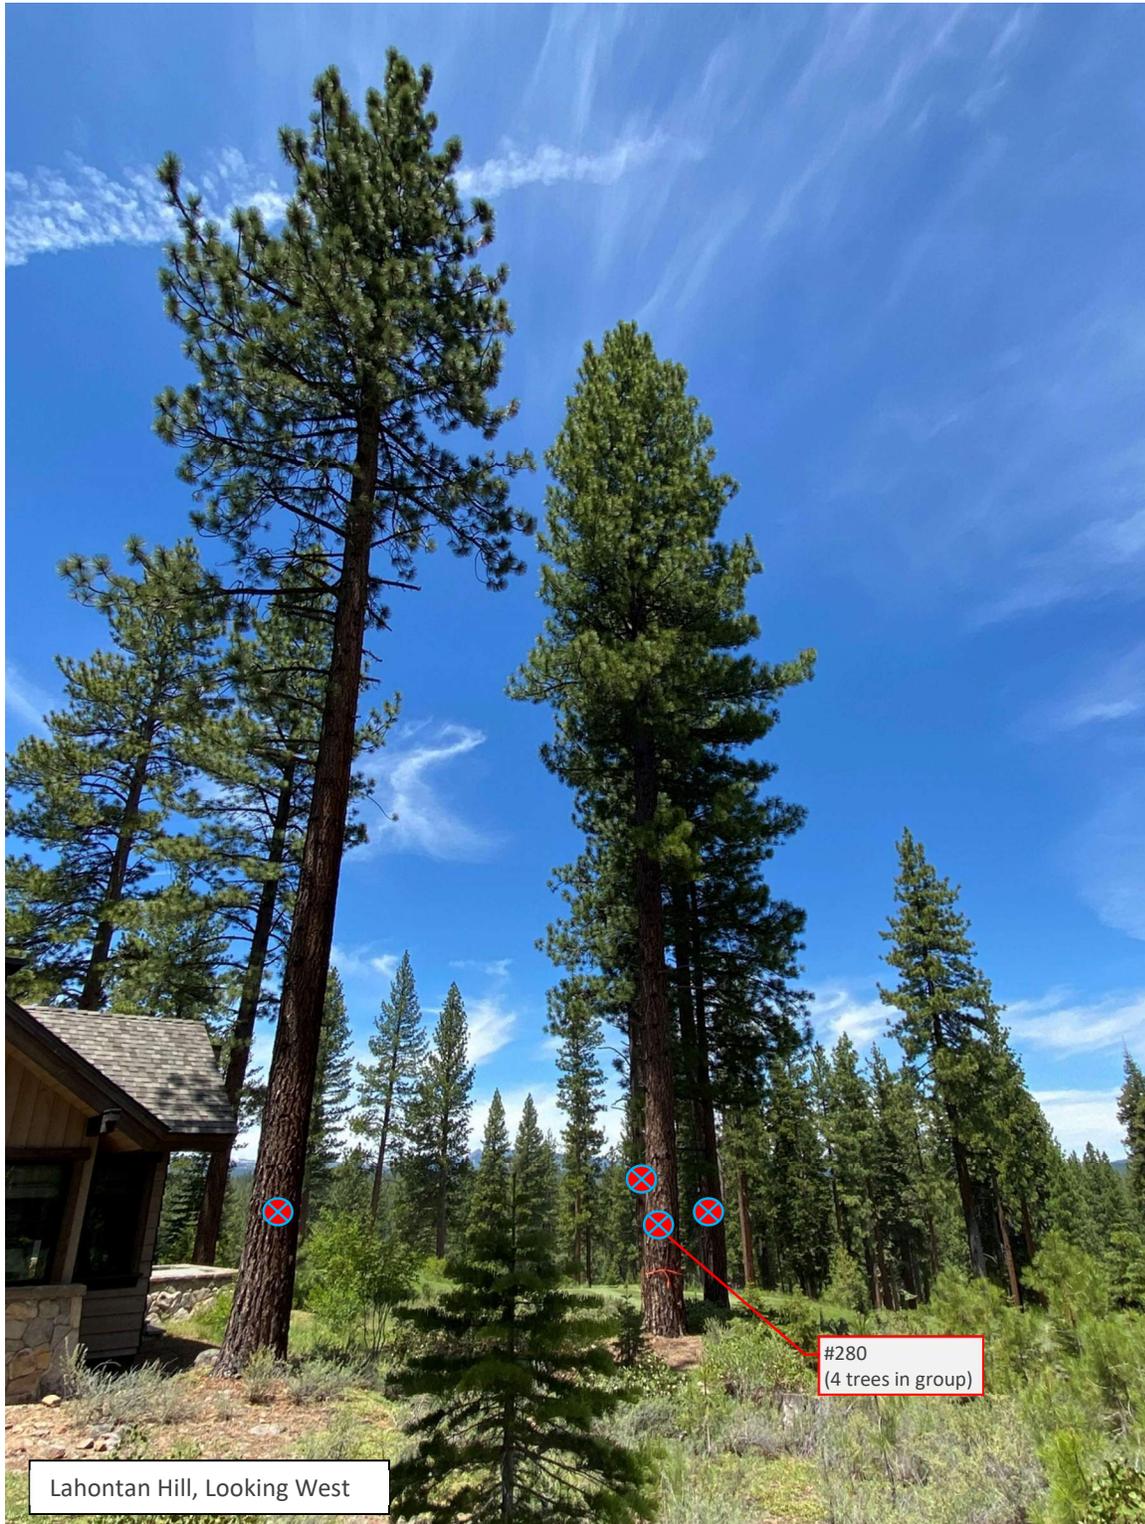
Photos taken on June 11, 2020, are included below to help the Airport identify trees on the ground, and trees that were grouped together.
